OXYGEN FILLER VALVE - MAINTENANCE PRACTICES

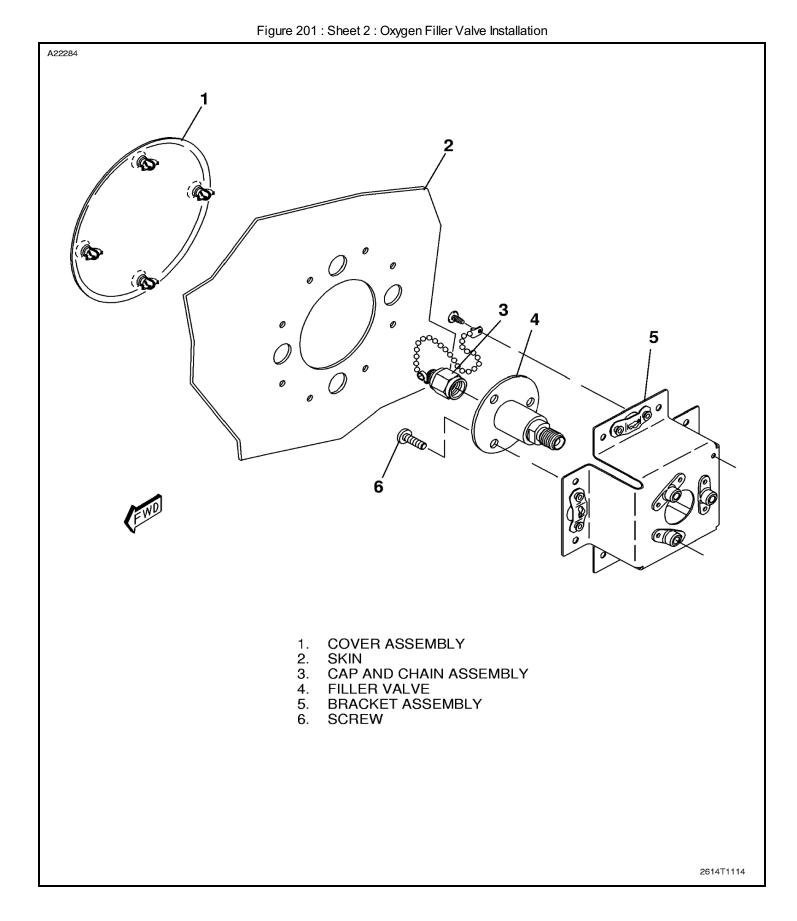
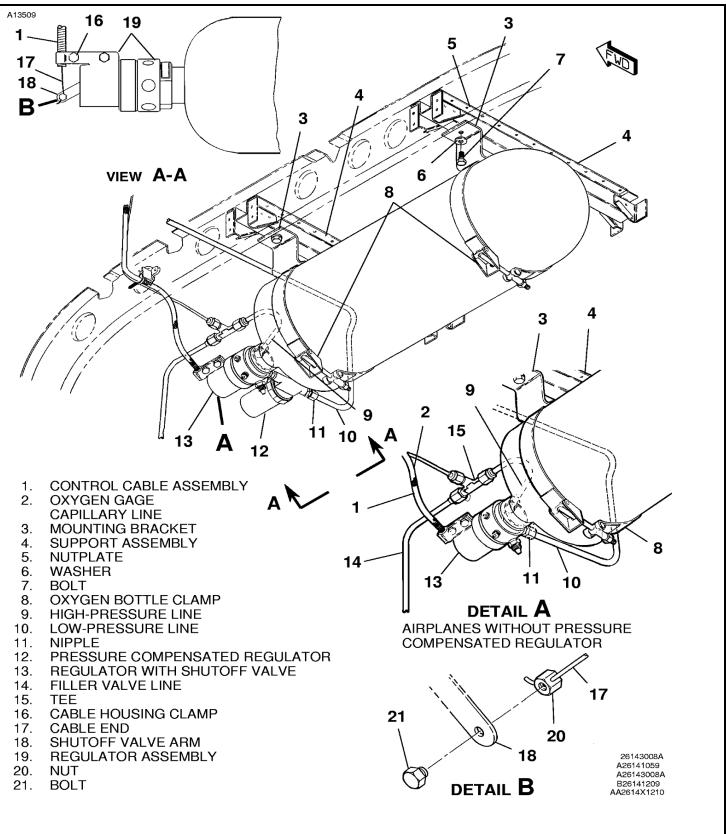
- A. Remove Oxygen Filler Valve (Refer to Figure 201).
 - (1) Remove aft baggage partition to gain access to filler valve assembly.
 - (2) Loosen line assembly (11) from filler valve body (10).

- (3) Unscrew filler valve from body filler valve end (5).
 - (4) Remove sleeve assembly (8) from filler valve end (5).
 - (5) Remove O-rings (12) and (13) from sleeve assembly (8).
 NOTE: The O-rings are the only field-repairable/replaceable parts of the filler valve assembly.

- (6) If filler valve end (5) is damaged, remove by loosening screws (4) from outside of airplane through access port.
- B. Install Oxygen Filler Valve (Refer to Figure 201).

- (1) Install O-rings (12) and (13) on sleeve assembly (8).
 - (2) Ensure that value core (9) is properly positioned in filler body assembly and bronze filter (7) is positioned in sleeve assembly (8).

- (3) Screw filler valve assembly into filler valve end (5).
 - (4) Attach line assembly (11) to filler valve body (10).
 - (5) Test for leaks.
 - (6) Reinstall aft baggage partition.
