CARGO POD - APPROVED REPAIRS

1. General

A. The following procedures are to be used for repairing delamination of outer or inner wall skin or both and the repairing of the bushing assembly and washer. The bonding action of the replacement core (Syntactic foam) will repair the delamination of the opposite wall skin.

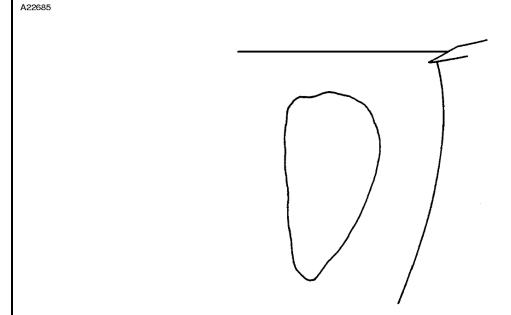
Figure 801: Sheet 1: Cargo Pod Repair

(a) LOCATE DELAMINATED AREA BY USING FINGER PRESSURE AGAINST CARGO POD SKIN AND/OR TAPPING SKIN WITH A COIN AND LISTENING FOR HOLLOW SOUND, THEN MARK PERIMETER OF DELAMINATED AREA. AREAS WITH A GOOD BOND WILL EXHIBIT A SHARP, CRISP SOUND.

- A. Refer to Figure 801 for illustrated repair steps.
- B. Repair the Bushing Assembly and Washer (Refer to Figure 802).
 - (1) Remove the latch assembly. Refer to Chapter 25 Cargo Pod Maintenance Practices.
 - (2) Remove the bushing assembly and washer.
 - (3) Clean surfaces to which sealant is to be applied with solvent. Refer to Chapter 20 General Solvents/Cleaners Maintenance Practices.
 - (4) Bond Bushing assembly and washer with Type I, Class B adhesive. Refer to Chapter 20 Adhesive and Solvent Bonding Maintenance Practices.
 - (5) The position of cam block stops in the bushing assembly must be typical to figure 802. Refer to Figure 802.
 - (6) Install the latch assembly. Refer to Chapter 25, Cargo Pod Maintenance Practices.

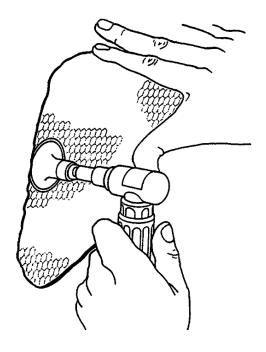
(b) USING A ROUTER, CUT OUT DELAMINATED SKIN.

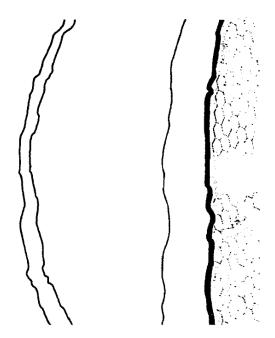
Figure 801: Sheet 2: Cargo Pod Repair

(c) REMOVE CORE IN DELAMINATED AREA AND BACK TRIM THE CORE 0.50 TO 0.75 INCH UNDER THE TRIMMED SKIN USING A ROUTER AND SANDER. BE CAREFUL NOT TO DAMAGE OPPOSITE SKIN.

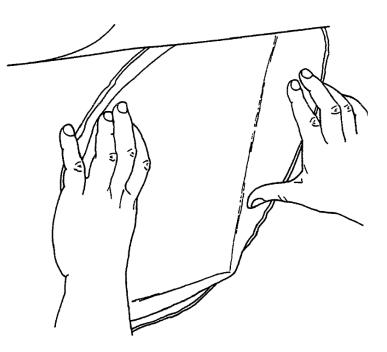
Figure 801: Sheet 3: Cargo Pod Repair

(e) CUT THREE PAPER PATTERNS. CUT EACH PATTERN TO MATCH EACH SUCCESSIVE PLY OF SKIN. USE THESE PATTERNS TO CUT THE 181 FIBERGLASS PATCH MATERIALS.

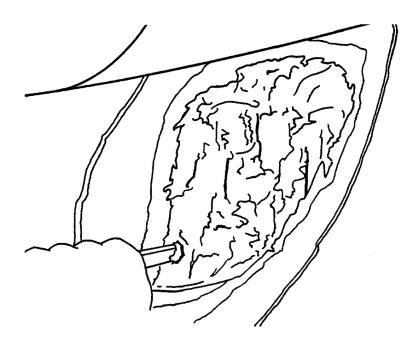
(f) MIX THE PROPER AMOUNT OF EC3524 SYNTATIC FOAM AND FILL PATCH AREA, STARTING AROUND THE EDGES AND WORKING FOAM INTO THE UNDERCUT AREA, TAKING CARE NOT TO TRAP AIR.

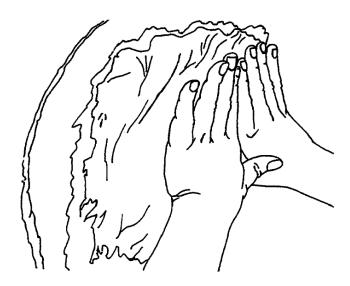
Figure 801 : Sheet 4 : Cargo Pod Repair

(g) COVER THE AREA WITH PLASTIC AND WORK IN BY HAND OR USE A PLASTIC SQUEEGEE. BE CAREFUL NOT TO LEAVE ANY LOW AREAS. REMOVE PLASTIC AND ALLOW FOAM TO CURE FOR 12 HOURS. A HEAT SOURCE MAY BE USED TO ACCELERATE CURE TIME. USE LOW HEAT, 100° F MAXIMUM AND DO NOT ALLOW AIR TO BLOW DIRECTLY ON FOAM.

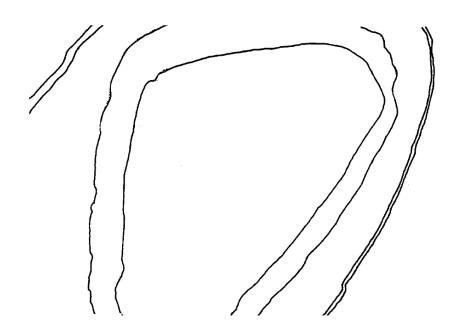
(h) SAND FOAM DOWN FLUSH WITH INNER KEVLAR LAYER.

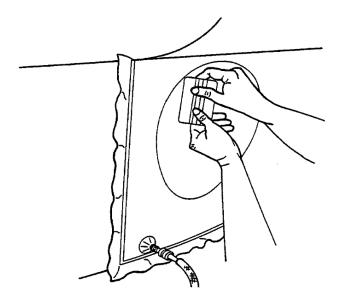
Figure 801: Sheet 5: Cargo Pod Repair

(i) OUTLINE PATCH AREA WITH PEAL PLY RELEASE FILM TACKY TAPE, LEAVING AMPLE SPACE AROUND PATCH AREA. CUT A SECTION OF PLASTIC SHEET TO FORM VACUUM BAG. HAVE VACUUM PUMP READY TO CONNECT.

(j) INSTALL HEXCELL 181 FIBERGLASS CLOTH PATCHES USING EA956 ADHESIVE, MAKING SURE EACH PATCH IS SATURATED AND NO AIR POCKETS ARE LEFT.

- (k) INSTALL VACUUM BAG AND CONNECT VACUUM PUMP, DRAWING A MINIMUM OF 20 INCHES OF VACUUM.
- (I) USING THE PLASTIC SQUEEGEE, WORK OUT ANY TRAPPED AIR AND EXCESS RESIN.
- (m) WITH VACUUM STILL CONNECTED, ALLOW A CURE TIME OF 24 HOURSCURE TIME MAY BE ACCELERATED BY USE OF A HEAT LAMP.
- (n) REMOVE VACUUM BAG AND SAND SURFACE, TAKING CARE NOT TO SAND INTO FIBERGLASS CLOTH.
