32-10-00-0

MAIN LANDING GEAR - INSPECTION/CHECK

TASK 32-10-00-220

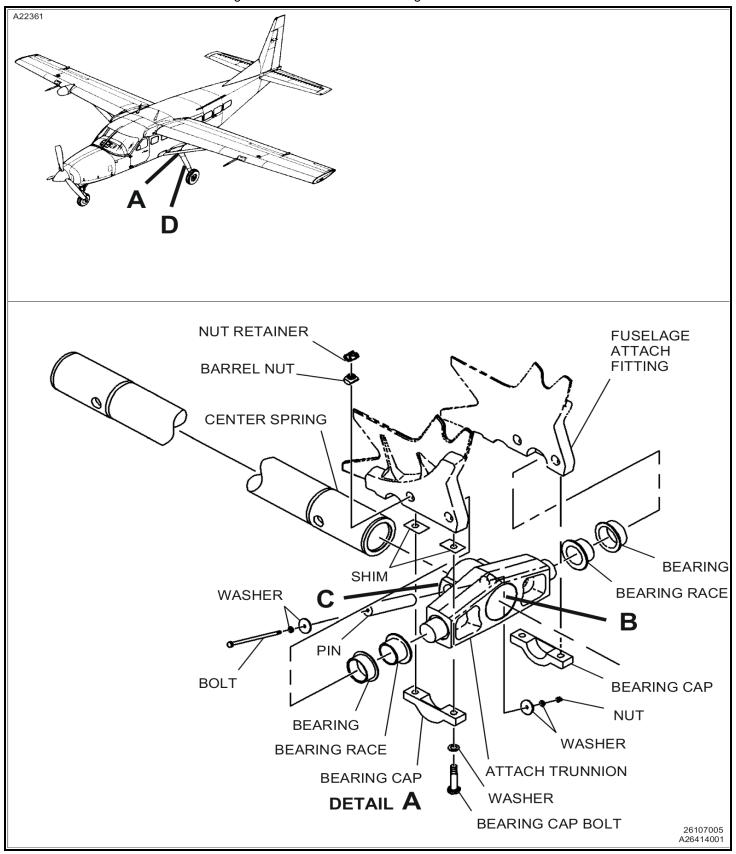
Figure 201: Sheet 1: Main Landing Gear Installation

A27669 **CLAMP BRAKE LINE CLAMP AXLE FITTING STRAP** (NOTE 2) (NOTE 1) **NUTS** NUT WASHER MAIN GEAR **PLATE SPRING** STRAF (NOTE 1) (NOTE 2) SPACERS **BRAKE DISC BOLT** SHIM **AXLE BRAKE CALIPER**

TORQUE PLATE

- (1) Examine the sealant at the main landing gear at the following locations for cuts, deterioration, dimensions and separation from the surfaces. Refer to Main Landing Gear Installation, Figure 201.

- (3) Use Type 1, Class B-1/2 sealant and apply a fillet seal around the main gear spring at the center spring. Refer to Main Landing Gear Installation, Figure 201.

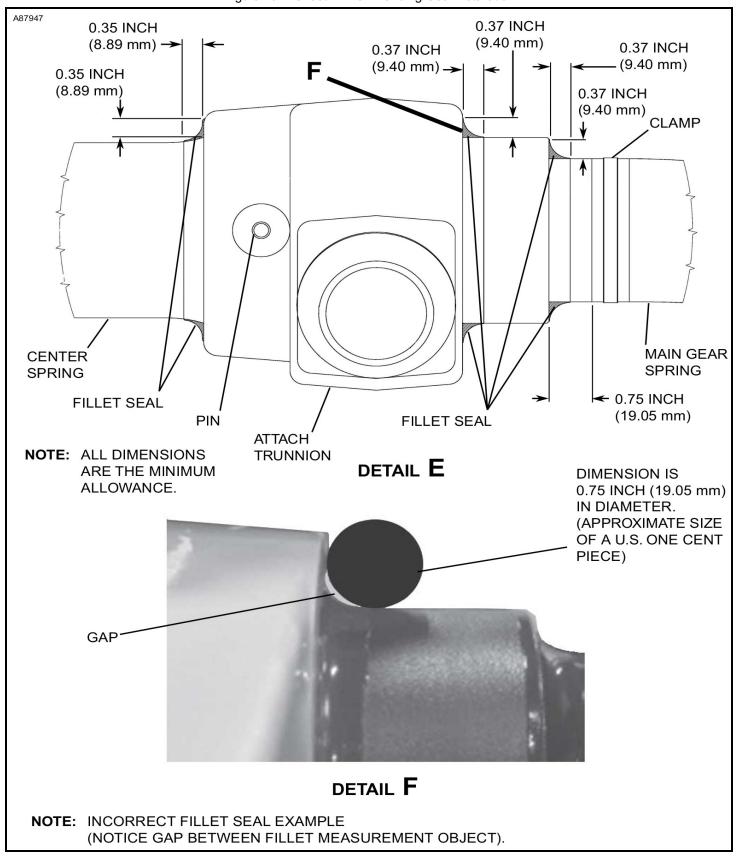
Figure 201: Sheet 3: Main Landing Gear Installation

A22362 FILLET SEAL FILLET SEAL CENTER MAIN GEAR SPRING **SPRING ATTACH** TRUNNION FILLET SEAL **AXLE FITTING** DETAIL D LEFT SHOWN RIGHT OPPOSITE **CENTER SPRING** (NOTE 2) PIN (NOTE 2) ATTACH TRUNNION (NOTE 2) MAIN GEAR **SPRING** DETAIL C C2341T4001 D2641T1018 (NOTE 2)
